Manhole Inspection Summary

Manhole # S43GG_041MH

Insp Date: **3/14/08 9:14 AM**

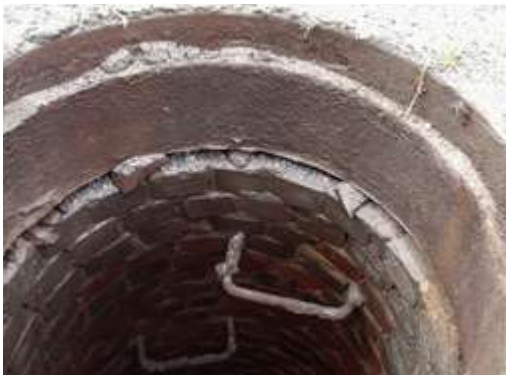
Defect 1

Offset: **1** (in.)

offset

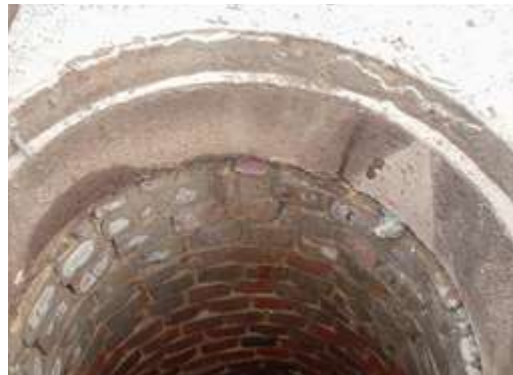
Defect 2

☒ **Leaks**

frame leaks

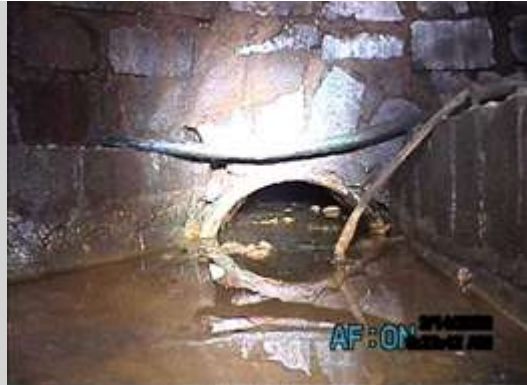
12 O'Clock Outflow

Pipe Height: **8.4** (in.) Rod and Bar (Angled)
Pipe Material: **Clay** ☐ Pipe Lined
Invert Depth: **11.50** (ft.) Flow Characteristics: **Slow**
Deposits: ☐ None ☒ **Mud** ☒ **Sludge** ☒ **Debris** ☐ Grease
Silt Depth: **4** (in.) Deposits Extent: **Medium**
Infiltration: **None** Pipe Seal Cond: **Sound**

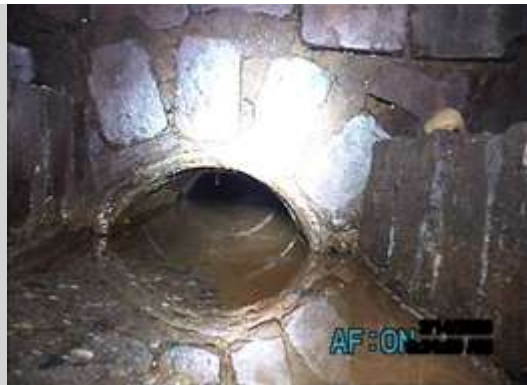
6 O'Clock Inflow

Pipe Height: **8.4** (in.) Rod and Bar (Angled)
Pipe Material: **Clay** ☐ Pipe Lined
Invert Depth: **11.40** (ft.) Flow Characteristics: **Slow**
Deposits: ☐ None ☒ **Mud** ☒ **Sludge** ☒ **Debris** ☐ Grease
Silt Depth: **4** (in.) Deposits Extent: **Medium**
Infiltration: **None** Pipe Seal Cond: **Sound**

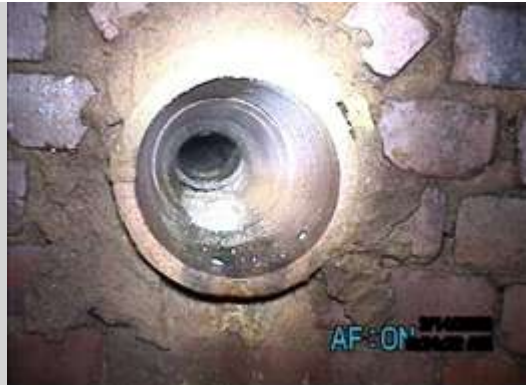
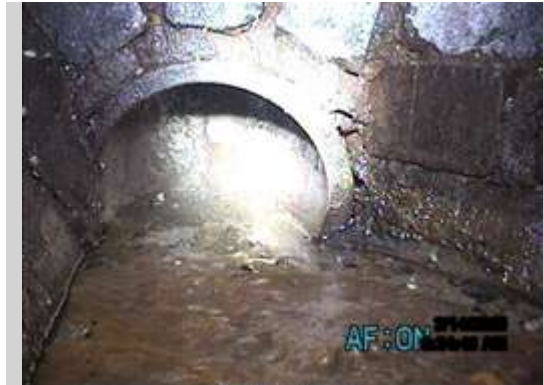
9 O'Clock Inflow

Deposits: ☐ None ☒ **Mud** ☐ Sludge ☒ **Debris** ☐ Grease

Silt Depth: **0.5** (in.) Deposits Extent: **Light**

Drop Condition: **Partly Clogged**
